INSPECTION CERTIFICATE

Client : Marmox Egypt Co.- chemicals For Modern Building International (CMBI)
Place of Inspection : Factory Of Marmox Egypt Co. at Wadi El Natrone Industrial Zone.
Date Of Inspection : 7th of April, 2021
Goods : Manholes and Grids Covers
Quantity : 221 pieces
Scope of Inspection : 1. Quantity check.
2. Packing.
3. Marking check.
4. visual inspection.
5. Sampling for Laoding Test.
6. Document review.

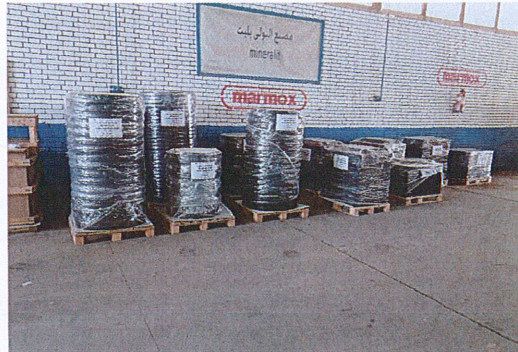
At time of inspection, the manholes and grids pieces were packed over wooden pallets and wrapped by stretch plastic cover.

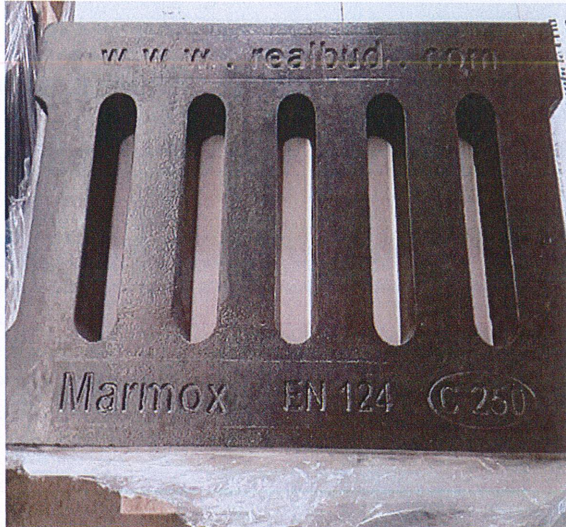
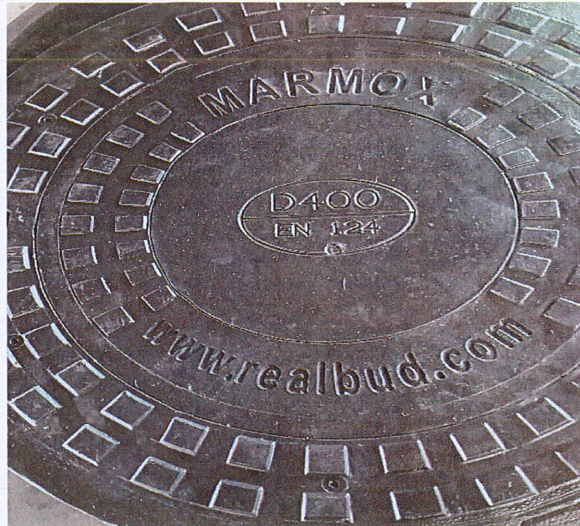
The manholes and grids were found to be casting stamped by the following marks :

- www.realbud.com
- MARMOX
- Number of related specification
- Load Class

The following photos are example of marking :

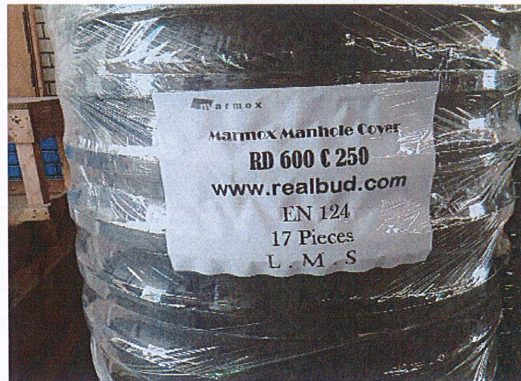
Each pallet was labeled by the number of pieces, load class, size, MARMOX and www.realbud.com

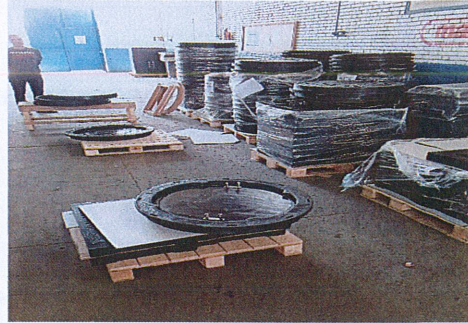
Samples of each manholes and grids were visually inspected and found to be newly produced products of good apparent condition.

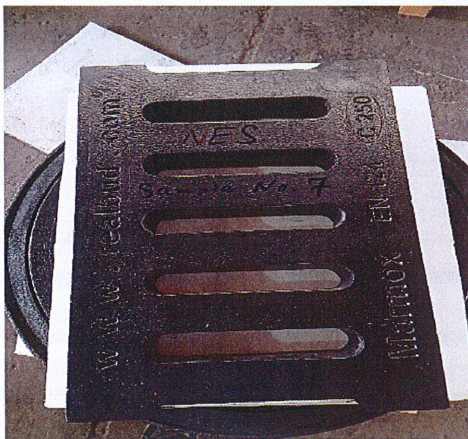
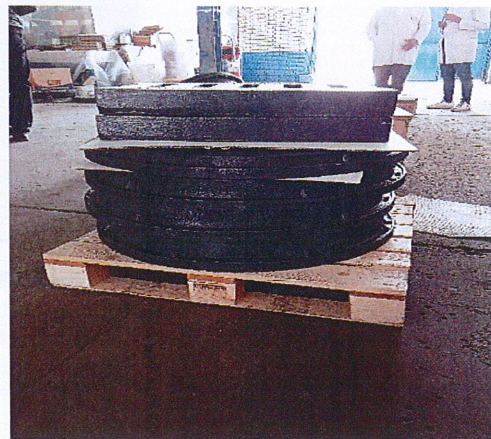
We randomly selected seven samples (one sample from each type), and were delivered by CMB representative in the presence of our inspector to the Concrete, Construction Test Laboratory at the “ Housing and Building National Research Center ” for load tested in accordance to its relative standards. The following are photos of some samples :

Test report issued by Concrete Construction Test Laboratories (CCTL) said to all the seven samples was carried out in accordance to ES 4207-5/2020 - EN 124-5/2015 and the samples was subjected to the following loads with no cracks observed :

1. For sample no. CI 550, manhole cover A15 - RD600, a load test of 1.5 ton with no crack and a deflection of 0.32 mm.
2. For sample no. CI 551, manhole cover B125 - RD600, a load test of 12.5 ton with no crack and a deflection of 0.69 mm.
3. For sample no. CI 552, manhole cover C250 - RD600, a load test of 25 ton with no crack and a deflection of 0.92 mm.
4. For sample no. CI 553, manhole cover D400 - RD600, a load test of 40 ton with no crack and a deflection of 1.1 mm.
5. For sample no. CI 554, manhole Grid D400 - BK67, a load test of 40 ton with no crack and a deflection of 0.95 mm.
6. For sample no. CI 555, manhole Grid C250 - BK67, a load test of 25 ton with no crack and a deflection of 0.69 mm.
7. For sample no. CI 556, manhole cover D400 - RD640, a load test of 40 ton with no crack and a deflection of 1.21 mm.
